# APPLICATION SERIES

## INFORMATION ON CENTRIFUGAL PUMPS

By John H. Horwath  
Engineer  
Ampco Pumps Company

### Why NICKEL ALUMINUM BRONZE for Sea Water Pumps

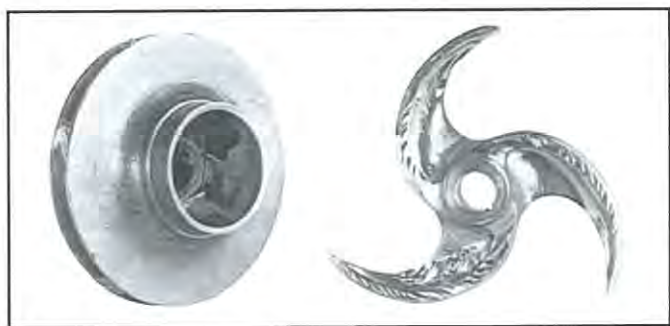
**FIGURE 1 — Compare the open impeller after 3 months, and the closed design after 3 full years of pumping the same slurry at identical speed, capacity and head. Open impeller, badly worn on vane faces, had lost so much capacity it had to be replaced.**

manufacturing limitations of another, sometimes more expensive, alloy having "superior" physical characteristics might not stand up nearly as well due to the highly destructive energy losses (wasted HP) that are being incurred. Below, Figure 1 of a closed impeller in bronze construction compared to an open impeller in Alloy 20 provides an actual case of this comparison.

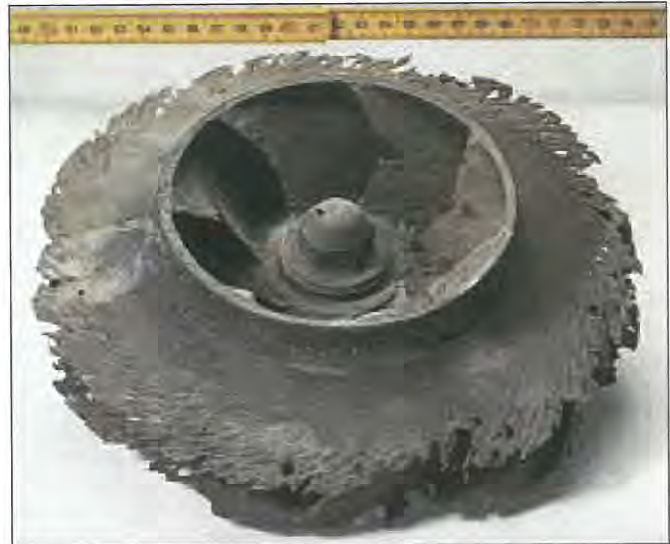
**FIGURE 4 — Cavitation**

Material selection as a means of minimizing cavitation damage has been done in an empirical manner based on experience, lab testing and actual performance in the field. Results have shown both nickel-aluminum bronze and 316 stainless steel to have good resistance to cavitating erosion as shown on Figure 4. Both are far superior to other common pump material such as gray iron, carbon steel, brass and 70-30 copper nickel.

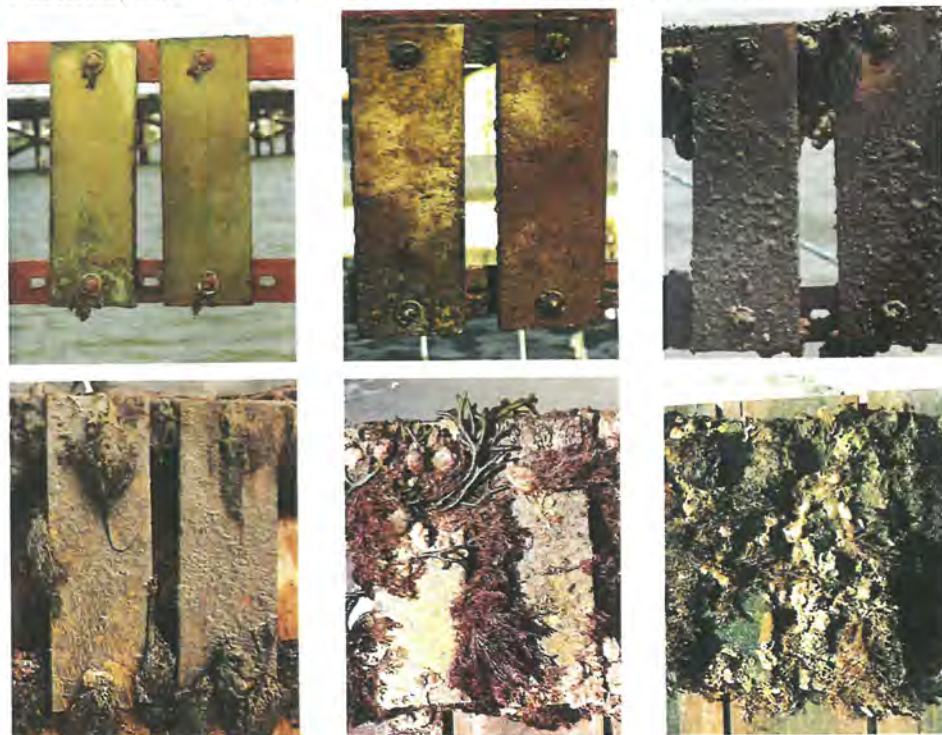
**FIGURE 6 — The five-year sequence of fouling on 90-10 Cu-Ni (CA 706) in sea water. Exposure periods are (from left to right): top—3 months, 9 months, months; bottom—36 months, 48 months, 60 months.**
